FROM THE FIELD

Hydronics troubleshooting

BY DAN FOLEY CONTRIBUTING WRITER

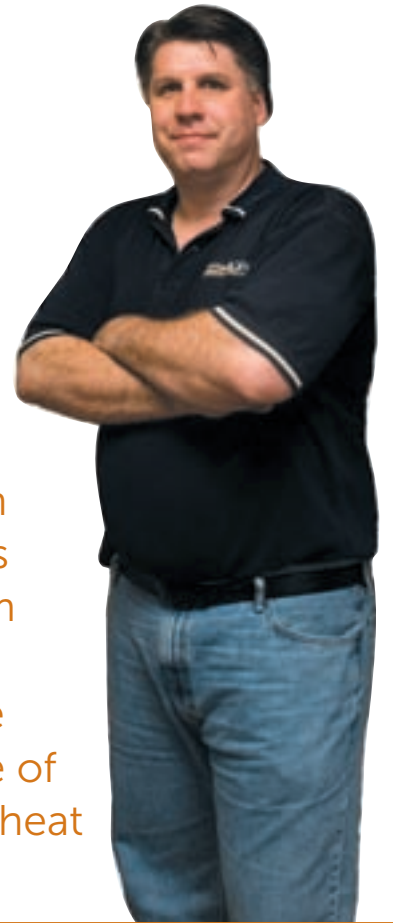
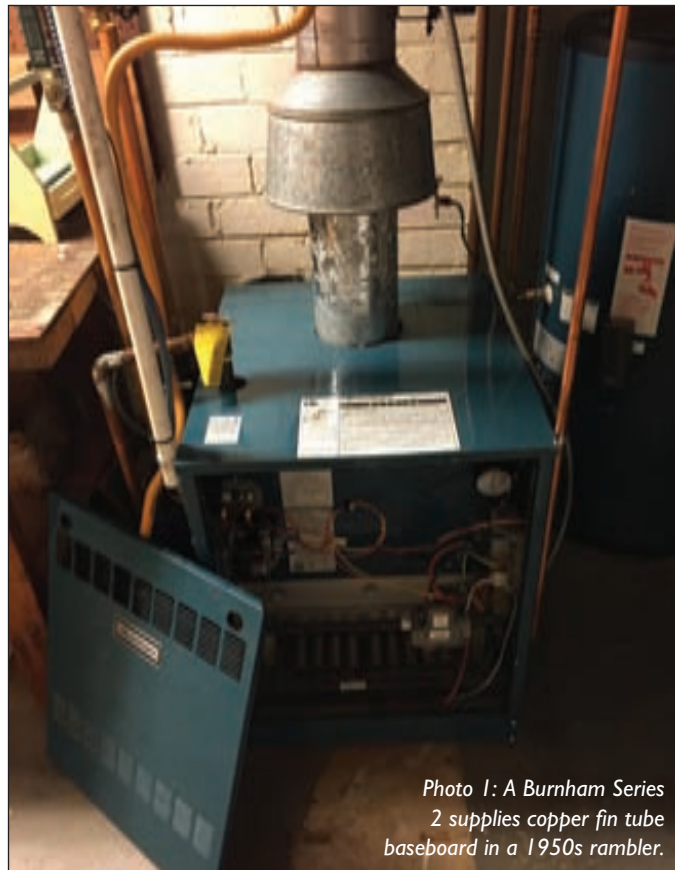
The first thing I did was set the thermostat up and observe the operation of the system. The boiler was a fairly new Burnham Series 2, approximately seven years old (See Photo No. 1). The relay clicked, the vent damper opened, the circulator pump kicked on, the pilot lit, then the main burners lit. The boiler and external controls were working properly.

Photo 1: A Burnham Series 2 supplies copper fin tube baseboard in a 1950s rambler.

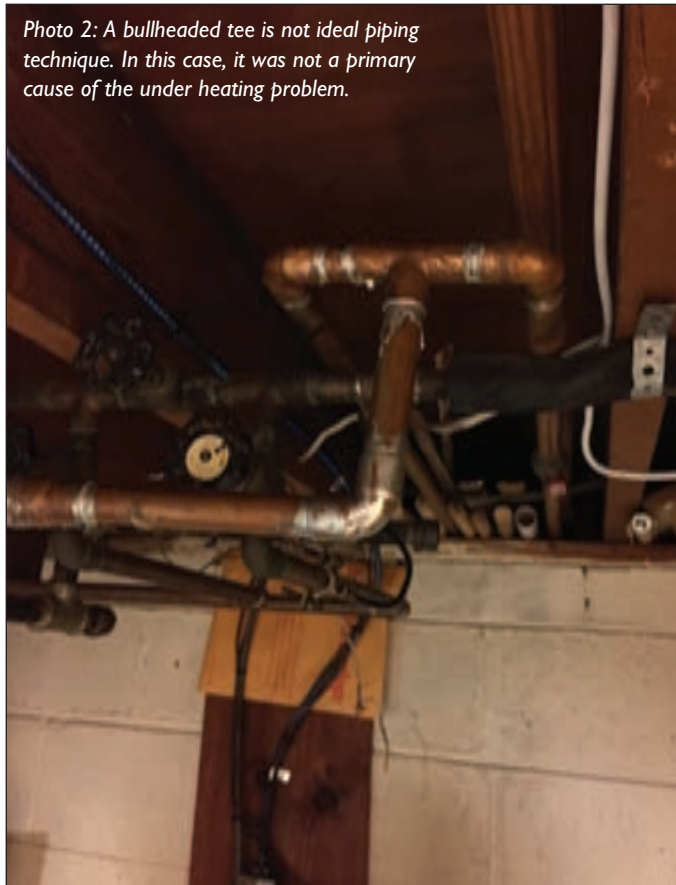
As the boiler came up to temperature, I sketched out the near boiler piping. Often, there is a maze of piping, and I find sketching it out makes it easier to spot piping problems. In this case, it was not textbook-perfect. The circulator was pumping towards the expansion tank. The primary supply dropped from 1 inch copper to ¾ inch copper, and then ran to a bull-headed tee (See Photo No. 2). While the piping was not ideal, it was not enough of an issue to cause the described deficiencies. It was not a "new" problem, as it had been that way since the boiler was installed.

Photo 2: A bullheaded tee is not ideal piping technique. In this case, it was not a primary cause of the under heating problem.

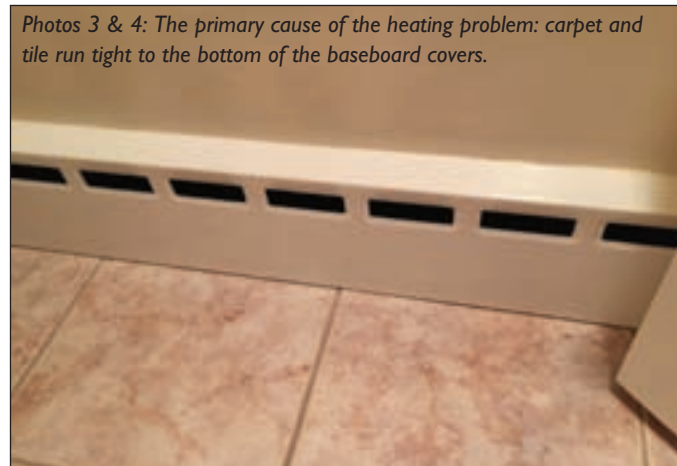
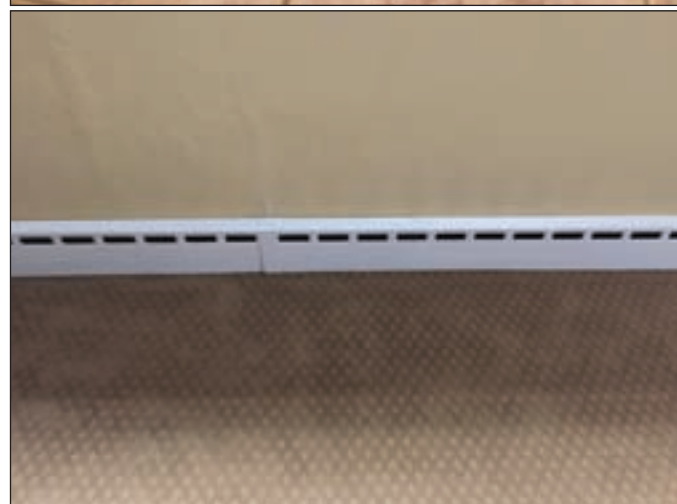
The next thing I did was survey all of the baseboard elements to make sure they were hot. I walked the entire house, and all of the fin tube element was scorching hot. But, one detail caught my eye. In several rooms, the finish floor ran tight to the bottom of the baseboard covers. Now, I was on to something. As mentioned earlier, copper fin tube baseboard requires airflow across the element to heat by convection. In this case, tile and carpet blocked this airflow (See Photo No. 3 and 4). A little heat would flow from the elements but not enough to maintain temperature in extremely cold weather. And, certainly not enough to make up a deep setback.

Photos 3 & 4: The primary cause of the heating problem: carpet and tile run tight to the bottom of the baseboard covers.

I found out that the home had been renovated a few years earlier. When the new floors went in, they ran them too high, right up to the bottom of the baseboard. This was the primary contributing cause of the system underperforming. The other problems noted contributed to the problem but the lack of convective airflow through the baseboard was by far the biggest factor.
