FROM THE FIELD

The right tool for the job

BY DAN FOLEY CONTRIBUTING WRITER

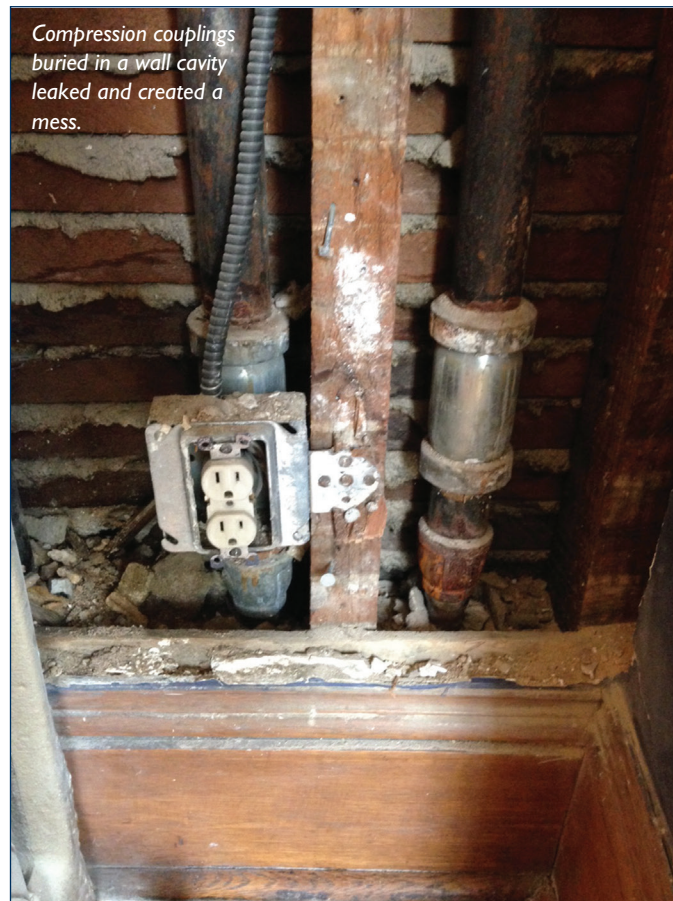
The owner's contractor opened up the plaster wall exposing the surprise. Dresser Couplings were used to connect the newer copper mains in the basement to the old steel risers. These are a type of compression coupling. I have seen them used on gas piping and on the fill and

vent piping on oil tanks. I have never seen them used on hydronic piping. In this case, they leaked in the walls and created a mess. Since this occurred back in June, Brian drained the system and shut it down while we came up with a solution.

Compression couplings buried in a wall cavity leaked and created a mess.

Brian came up with what I thought was a brilliant solution. He cut the risers square with an angle grinder. He then cleaned up the raw steel pipe with a file and a chamfer tool. He cleaned and sanded the pipe to bare metal. He used Viega MegaPress steel fitting to transition from 1-1/2 inch steel pipe to 1 inch copper. A press tool with the correct jaws then applies 35,000 PSI of pressure on the fitting creating a tight, permanent connection. He completed the repair by tying into the copper mains in the basement using Viega Pro-Press copper fittings.

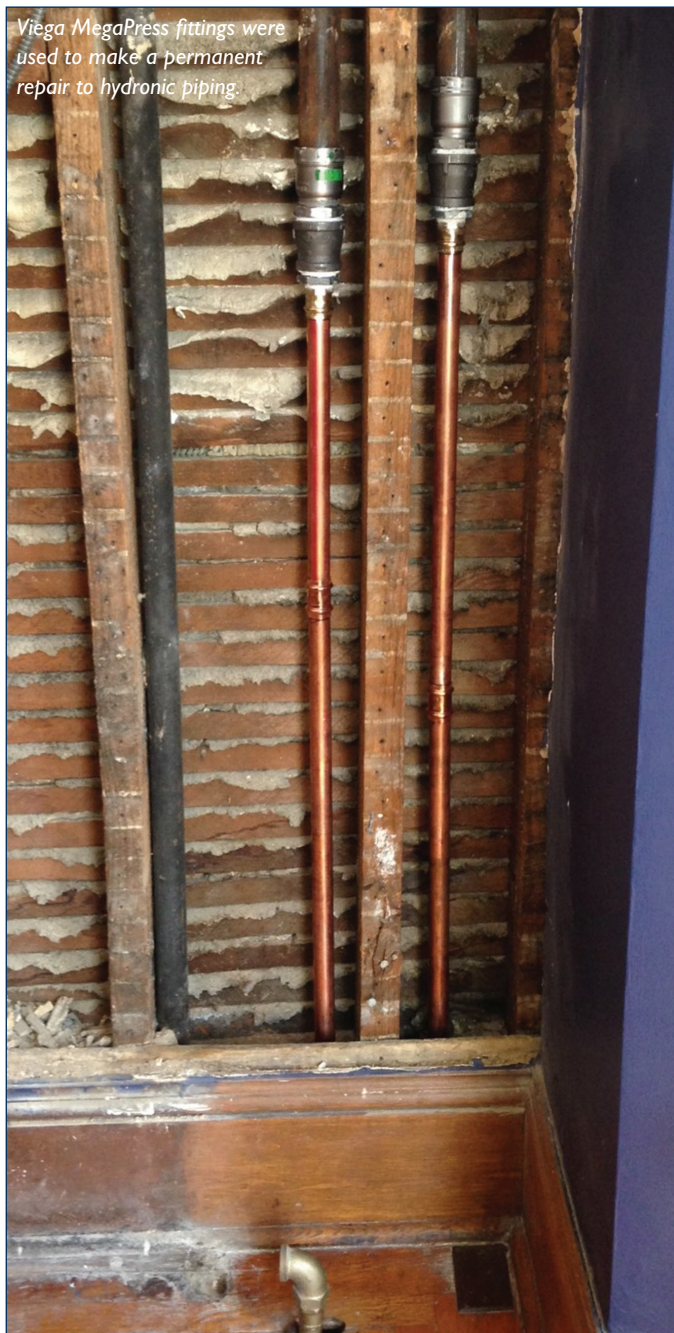
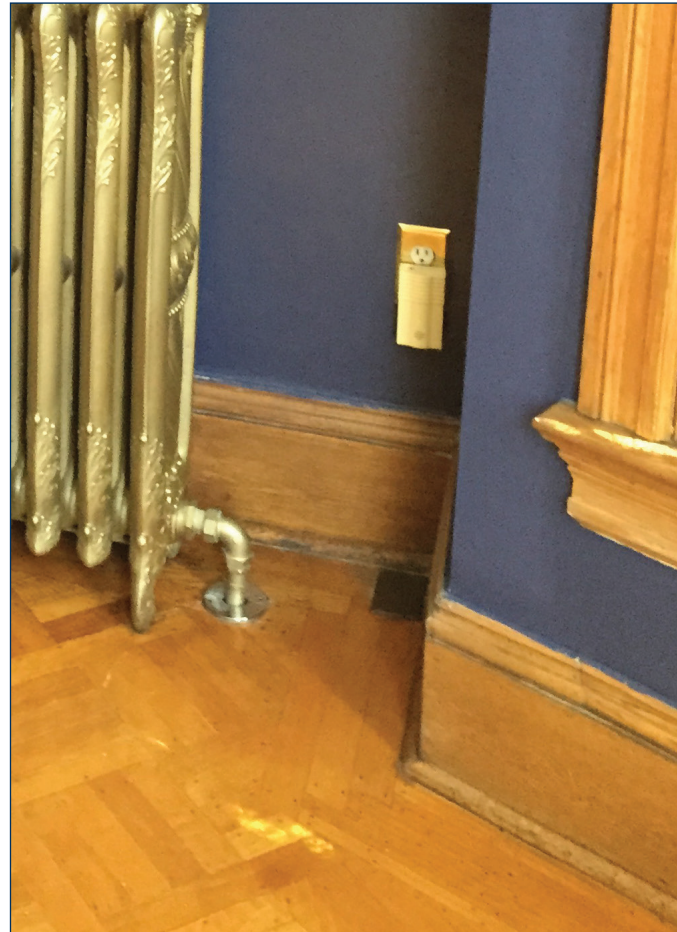
After plaster repair and painting, there is no sign that extensive piping repairs were made behind this wall.

Brian's solution created a solid, permanent repair to the hydronic piping with minimal collateral damage to adjacent floors, walls and finishes. The press fitting technology also avoided brazing and soldering in tight wall and ceiling cavities around dry, 100-year-old framing. Once the piping repair was completed and the wall was patched and painted, you would never even know we were there.

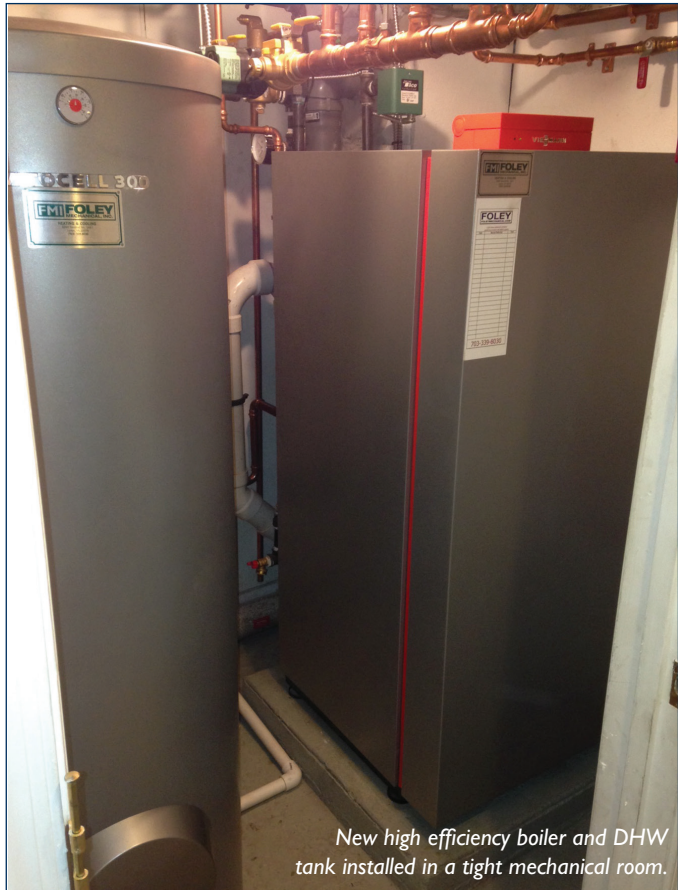
New high efficiency boiler and DHW tank installed in a tight mechanical room.

Brian installed a new 95 percent AFUE modulating, condensing gas boiler and an 80-gallon stainless steel indirect water heater. All of the zone controls and boiler specialties were replaced as well. Space was tight but Brian got it all to fit. Since this was a row house with two party walls, boiler venting was a challenge. There was no way to vent to an outside wall. Instead, a Centrotherm PPS flexible liner kit was dropped down the existing chimney flue and connected to the boiler to resolve the venting issue.
