FROM THE FIELD

Commercial Steam – Part II

BY DAN FOLEY CONTRIBUTING WRITER

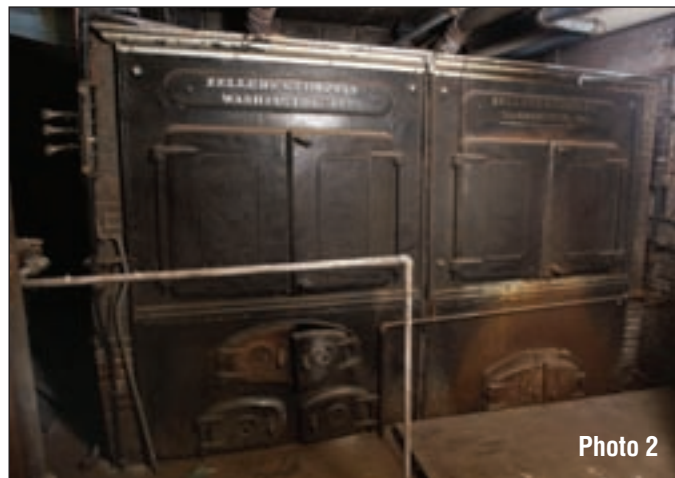
Photo 2

The seven-story building is heated by a one-pipe steam system connected to column-style cast iron radiators. The original coal fired boiler is still in place, as the building was built around the boiler (See Photo 2). It has long been disconnected. When we started working on the system, a 40-year-old Weil-McLain MGB steam boiler provided heat. When service calls started to be a weekly occurrence and we had replaced most of the operational parts on the boiler, the building committee decided it was time to consider replacing the boiler.

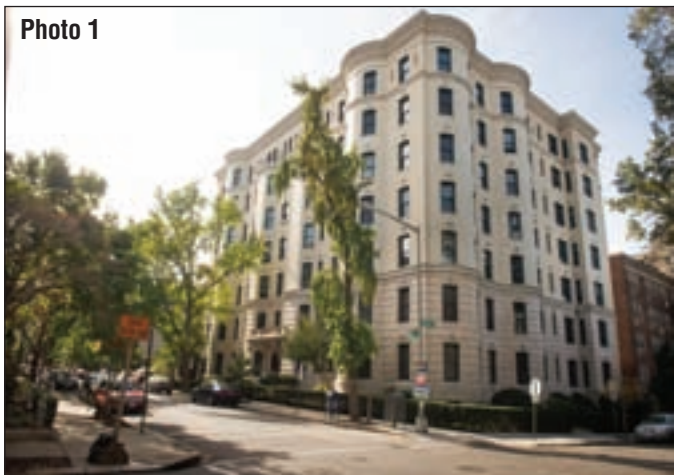
Photo 1

The Mendota, built in 1901, is D.C.'s oldest intact luxury apartment building (See Photo 1). It was the first of 25 apartment houses to be built in Kalorama Triangle, near the Connecticut Avenue trolley line. This area was considered the far north suburbs of D.C. at the time of construction. The 49 apartments featured 10-foot ceilings, transom windows, built-in corner cabinets, corner marble sinks, and claw-foot enamel bathtubs. The apartment building was converted to a co-op in the 1950s.

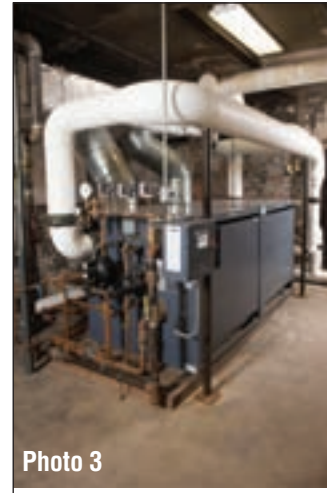
Photo 3

As this was a two-week project, we would only attempt a job like this over the summer. The board accepted my proposal, and Brian and his crew installed a new Weil-McLain LGB-20 steam boiler (2.47M BTU/hr.). (See Photo 3.) The boiler was sized to the connected radiation using a 1.5 pick-up factor. The header was re-piped to manufacturer specifications.

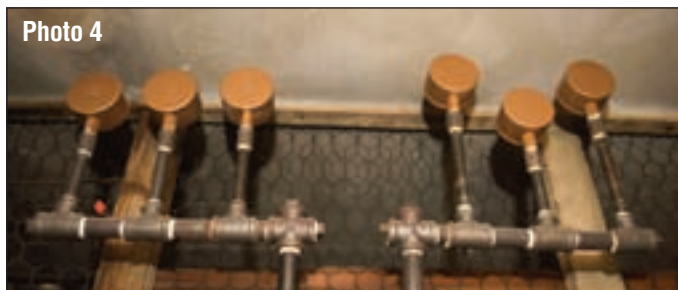
the system run for several weeks and flushed out all the sediment and total dissolved solids (TDS) that returned back to the boiler. After flushing the boiler and wet returns, Brian skimmed the water line until it ran clear. This step is critical and takes time; there is no short-cut. Skip this step and you will be back doing it for free. I prefer to build it into my price and get paid for it.
