# FROM THE FIELD

## Legacy systems

BY DAN FOLEY CONTRIBUTING WRITER

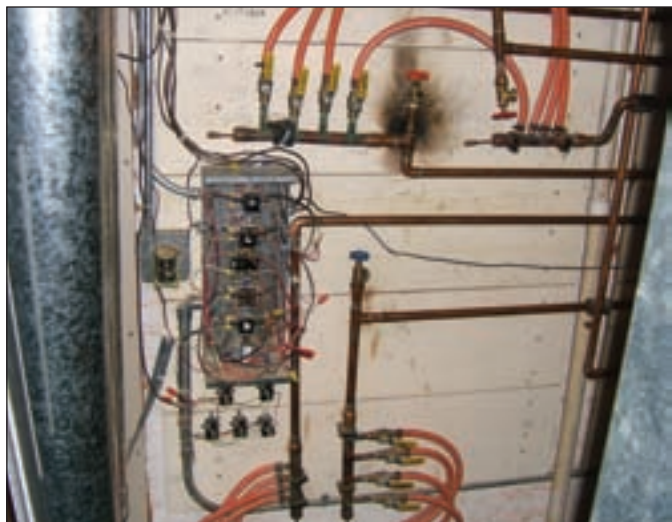
At the manifolds, several of the barbed fittings were leaking. The tubing was becoming hard and brittle.

At the manifolds, several of the barbed fittings were leaking. The tubing was becoming hard and brittle for several inches above most of the manifold connections (See Photo 1). Mixed water temperature was controlled through manually set thermostatic mixing valves. These were scaled up and corroded and no longer functioning properly, allowing 165 °F supply water temperature to the manifolds.

All the manifolds were replaced with new stainless steel manifolds with integral balance and isolation valves.

tubing was getting brittle and discolored near the barb and clamp connections. I chose to replace all the manifolds with new stainless steel manifolds with integral balance and isolation valves (See Photo 2).

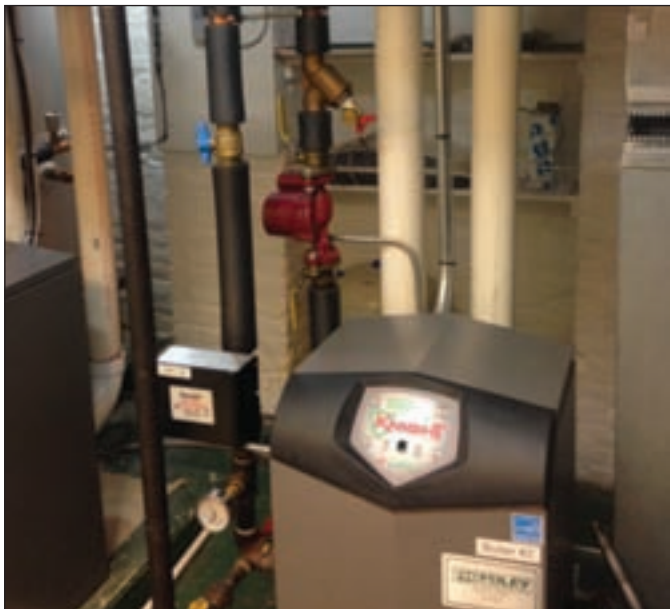
After the system was clear, refilled and purged, we introduced two gallons of boiler treatment.

After the system was clear, refilled and purged, we then introduced two gallons of Rhomar Pro-Tek 922 boiler treatment. This treatment acts as an oxygen scavenger and corrosion inhibitor prolonging the life of the tubing and the ferrous components of the system. It also maintains system efficiency by preventing corrosion debris from fouling the system.
