FROM THE FIELD

Chiller dilemma

BY DAN FOLEY CONTRIBUTING WRITER

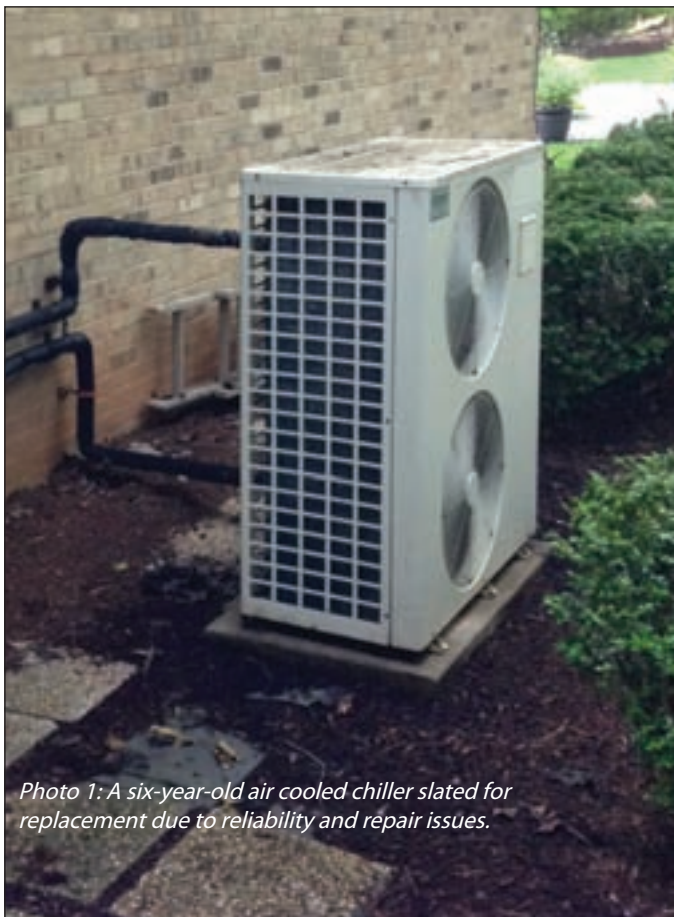
Photo 1: A six-year-old air cooled chiller slated for replacement due to reliability and repair issues.

I recently received a call from a client in Northern Virginia. We had installed a 5-ton package chiller in her home about six years ago for over \$10K. See photo No. 1. Since that time, we have replaced contactors and capacitors, repaired refrigerant leaks in the cap tubes as well as the compressor piping, and changed the chilled water pump, hard start kit, condenser fan motor, and temperature control. Last June, we replaced a failed compressor. She calculated that she had paid for the unit twice!

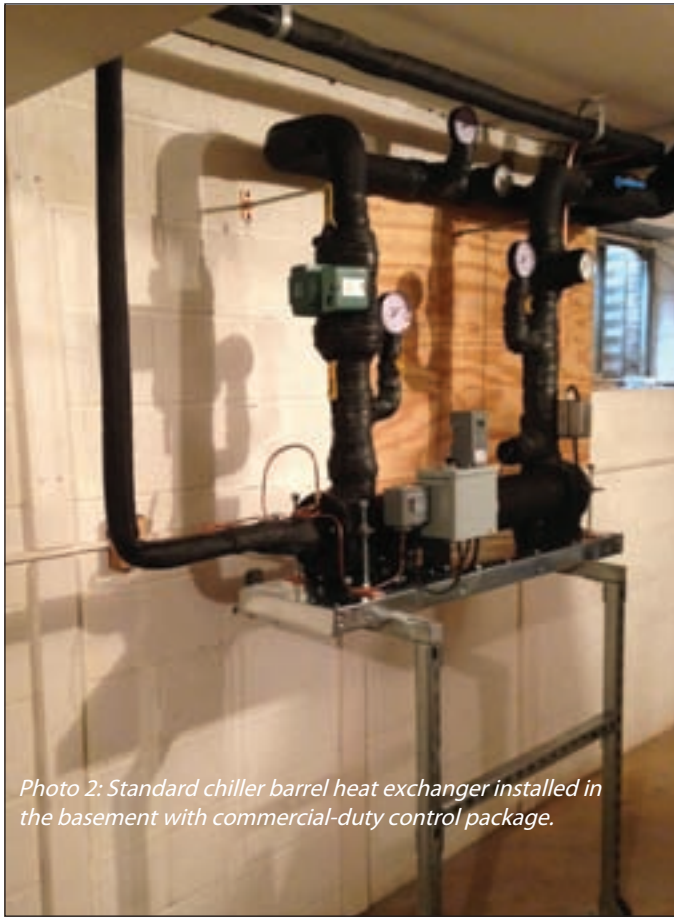
Photo 2: Standard chiller barrel heat exchanger installed in the basement with commercial-duty control package.

I did some research and found that Standard Chiller still makes this type of system. My solution was to install a Trane XL16i condenser piped to a Standard Chiller barrel in the basement. All the controls and components are heavy-duty commercial duty (See photos No. 2, 3 and 4). My technicians have total control of the quality of the installation, components, brazing, control wiring, and power wiring. This way, the reliability and quality of the installation is entirely under our control.

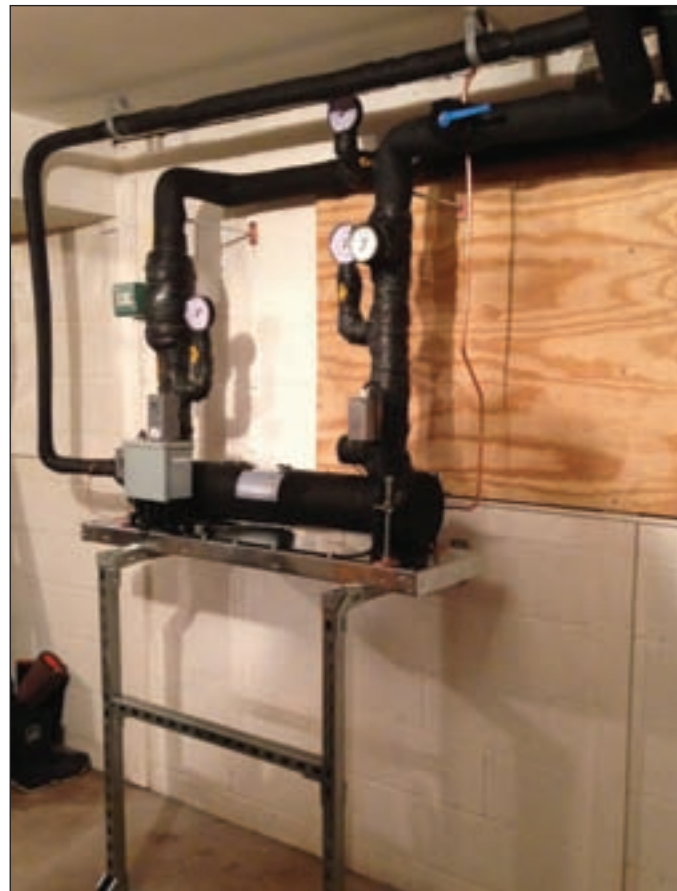
Photo 3: Reverse angle on the standard chiller barrel heat exchanger.
