The case of the missing chimney cap

Wrong chimney cap

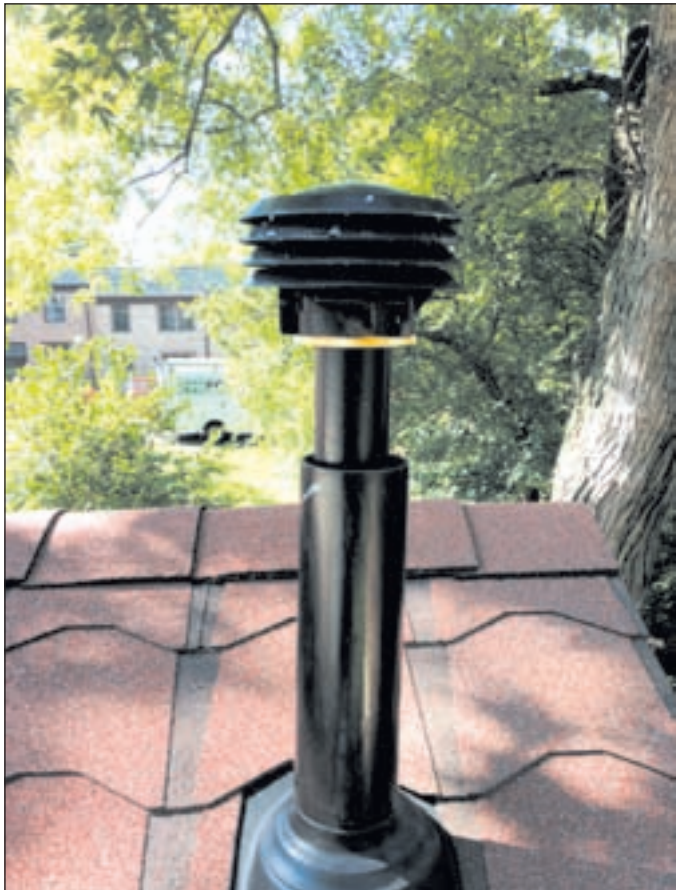
Photo #1: The vent cap on the boiler concentric vent kit was replaced by the roofer with a PVC bushing and B-Vent termination without informing anyone.

The jury-rigged termination caused two problems. First, when it rained, water and moisture would get into the combustion air intake. The second, more damaging issue was that this set-up allowed for flue gas recirculation under certain conditions. This is what was causing the

flame sensor to corrode and scale up so quickly. The incomplete combustion also caused the heat exchanger to foul up (As shown in Photo 3).

After a detailed investigation, Brian located the problem as I knew he would. What he found was astounding, as it never occurred to me to even check for this. A little over a year ago, roof work was done on the apartment. The roofer must have removed the concentric vent termination and lost it. He replaced the OEM PVC termination with a PVC bushing and a B-vent termination (See Photo 1). While this may have looked good, it caused problems with the boiler combustion. Brian had a new concentric kit delivered and replaced the roofer's work with the correct termination (Photo 2).

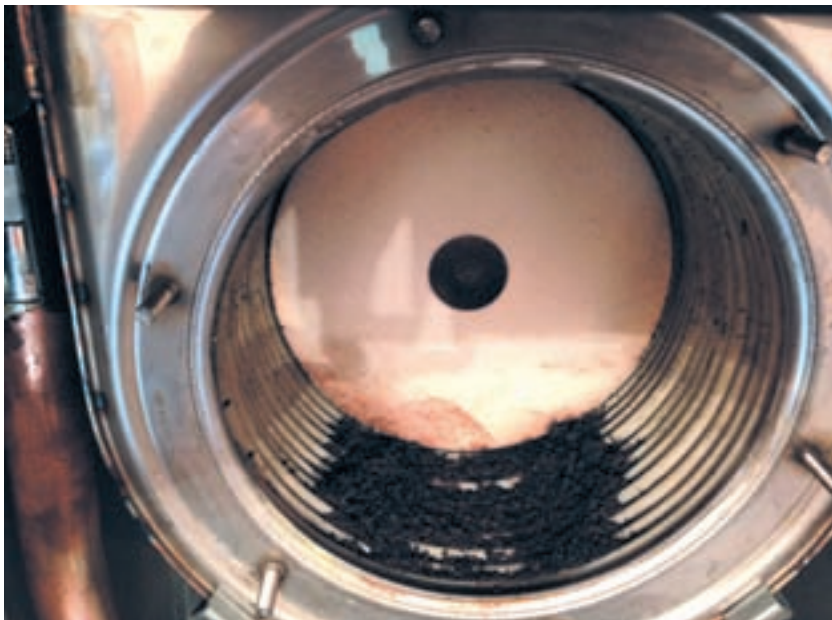
Photo #3: Debris in boiler heat exchanger caused by incomplete combustion due to recirculated flue gases.

It was only after packing up and leaving, as the temperature approached set point, that the modulating draft motor would spool down and the flue products would gently waft out of the vent. If the air was still or the breeze was just right, the flue products would get sucked right back into the intake causing our problem.

After Brian installed the correct termination, cleaned and vacuumed the heat exchanger and replaced the flame sensor, he performed a combustion analysis with his Testo 325 and printed a file copy. The numbers were dead on and DHW was restored. This was about six weeks ago and so far, all is well.

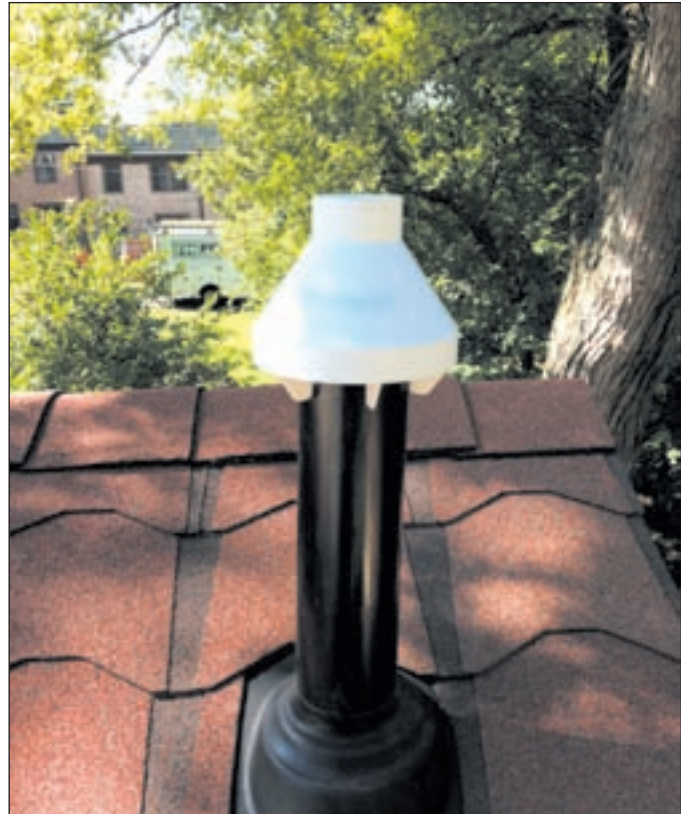
Photo #2: Boiler concentric vent kit with the correct termination installed.
