## FROM THE FIELD

## The chimney that would not draft

BY DAN FOLEY CONTRIBUTING WRITER

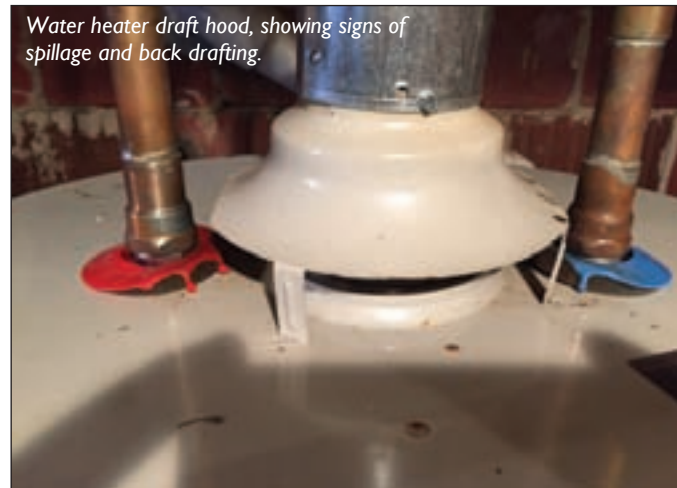
As I have written in previous columns about troubleshooting, I always ask myself, "What has changed?" One thing I noticed was that the water heater had been replaced. Closer inspection revealed that the water heater had been back drafting as well. The plastic grommets next to the draft hood were partially melted (See photo).

Water heater draft hood, showing signs of spillage and back drafting.

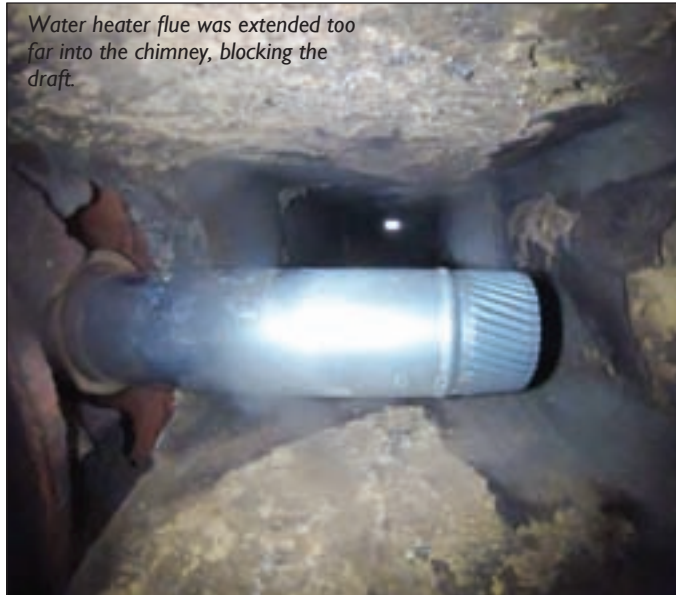
A chimney specialist was called in to survey the chimney and see if a liner was necessary. He pulled the boiler flue from the thimble and took a picture of the clay tile chimney liner. The cause of the draft problem for both the water heater and boiler was quickly identified.

When the water heater was replaced, the installer also replaced the vent connector. His mistake was inserting the vent connector too far (See photo).

The water heater flue was pushed all the way across the tile liner, touching the opposite side of the liner. This blocked the draft for the water heater. It also inhibited the draft of the boiler flue pipe below. It did not totally block the flue, but it caused enough draft resistance to trip the draft switch during cold weather when the burner ran for long cycles.

My technician, Ron Etter, pulled the water heater flue pipe, trimmed it to length and re-installed it (See photo).

A draft test confirmed that both the boiler and water heater were now drafting properly.

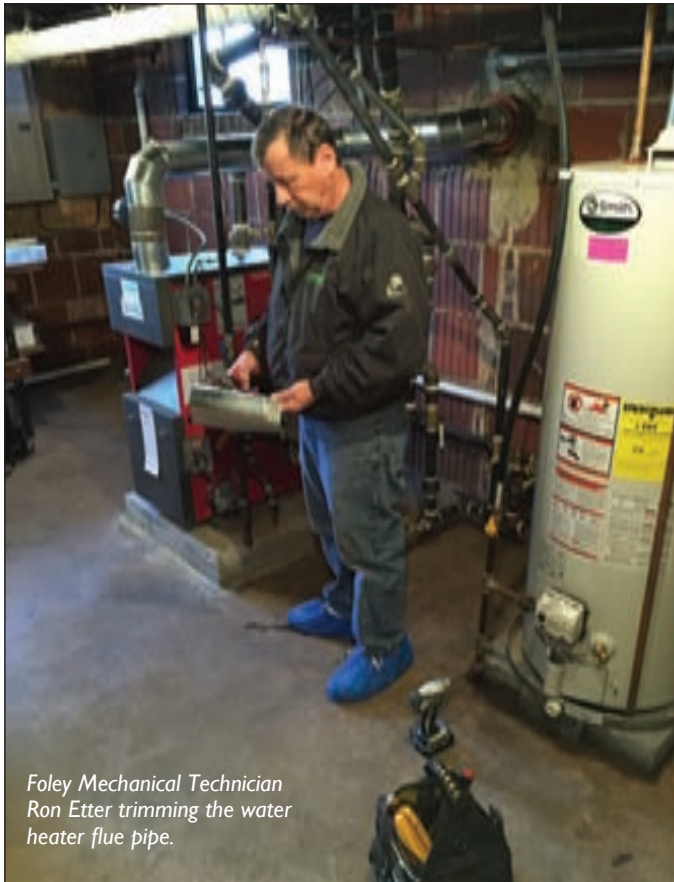
Foley Mechanical Technician Ron Etter trimming the water heater flue pipe.

This repair was done in February, and there have not been any additional call backs since. My client was thrilled to learn that a chimney liner was not necessary and that the problem was fixed. I try to keep an open mind when troubleshooting, but sometimes the cause of the problem is unexpected and unanticipated. ●
